# CONSTRUCTION MATERIALS TECHNOLOGIES

**To:** Corinne Schevin **Date:** June 23, 2014  
**From:** Jason Simmons  
**Subject:** Test Status for Bora Bora

Product samples were received from Tikimundo on April 21, 2014 for testing in accordance with **ASTM D 3161-13: Standard Test Method for Steep Slope Roofing Products (Fan Induced Method)**. Results for the testing are contained below.

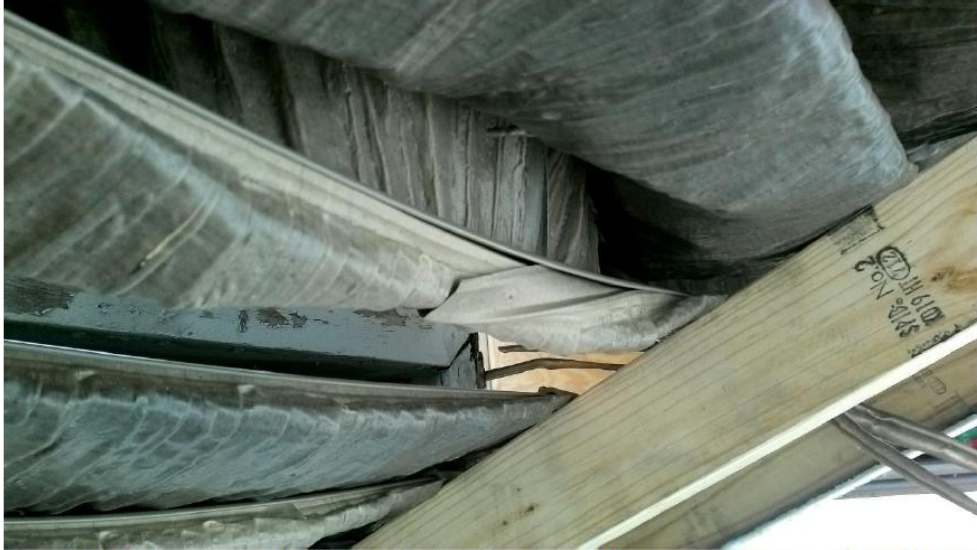
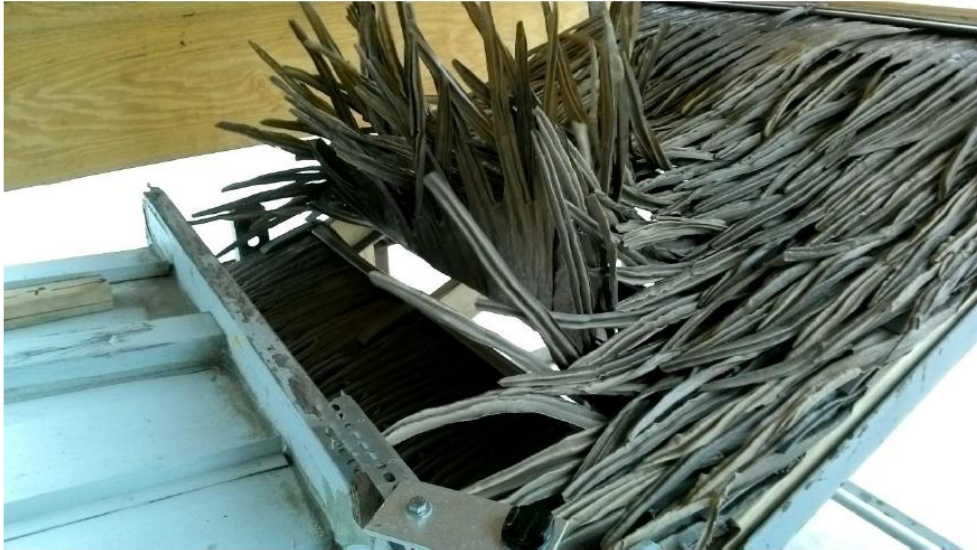
Test Observations	
Run Time (min)	Comments
Power on (130 mph)	leaves lifted at start rows 4, 5, 6, 7
1	leaves lifted at start rows 4, 5, 6, 7
21	leaves lifted at start rows 4, 5, 6, 7 (row 4 corner of leaf detached from bracing)
45	leaves lifted at start rows 4, 5, 6, 7 (row 4 corner of leaf detached from bracing)
119	leaves lifted at start rows 4, 5, 6, 7 (row 4 corner of leaf detached from bracing) client pushed leaves down and fixed the corner of the leaf and reinstalled it back in the bracing
7min down time	
140 mph 0.5	leaves lifted at start rows 4, 5, 6, 7 (row 4 corner of leaf detached from bracing)
150 mph 5.5	leaves lifted at start rows 4, 5, 6, 7 (row 4 corner of leaf detached from bracing)
160 mph 10.5	leaves lifted at start rows 4, 5, 6, 7 (row 4 corner of leaf detached from bracing)
End

Representative Photograph Deck #1: One leaf has disengaged from rail at 29 minutes into testing at 130mph

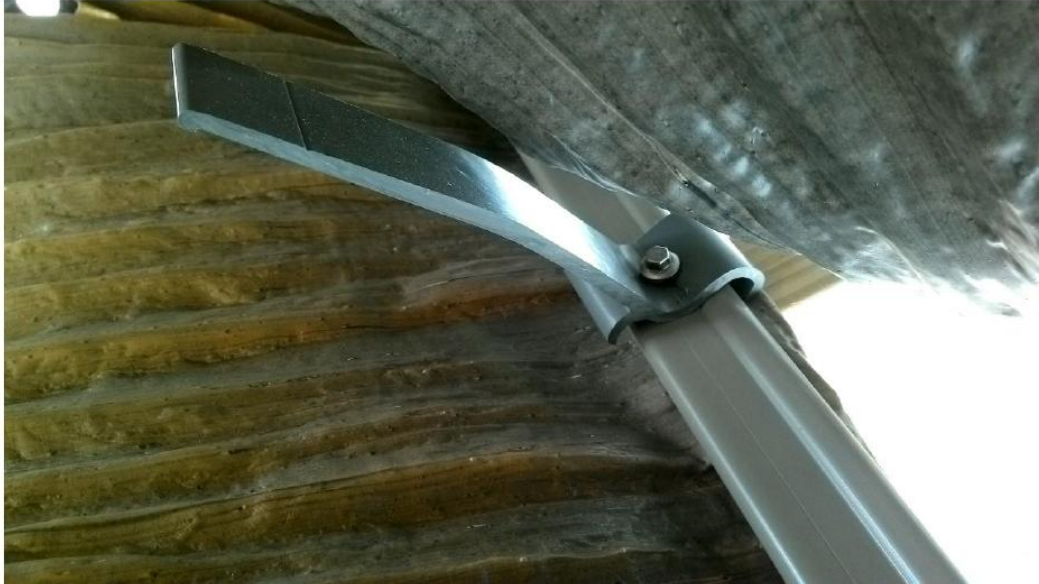
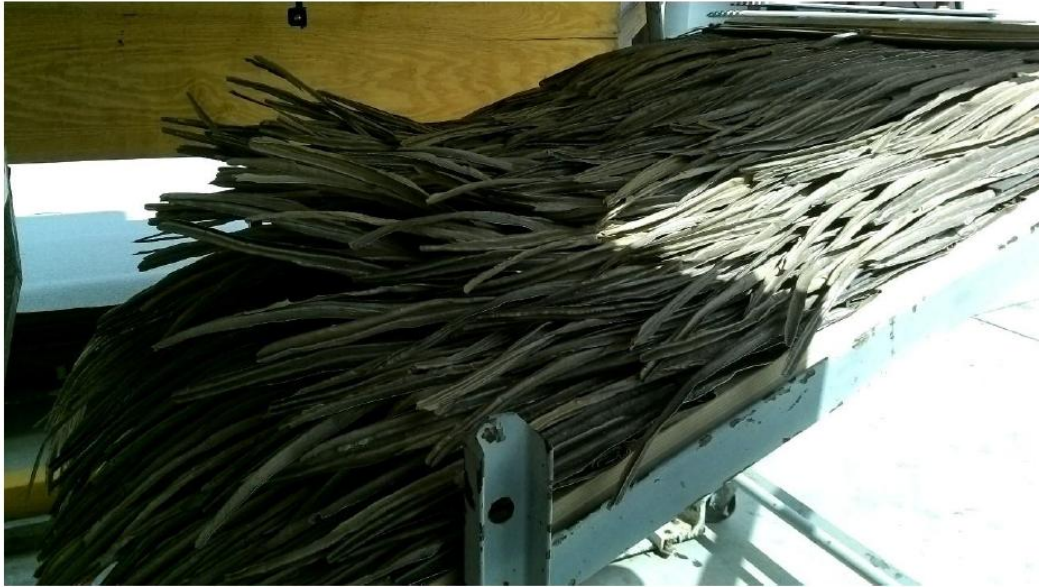
Test Observations	
Run Time (min)	Comments
Start	rows 4, 5, 6, 7, 8 lifted
0.5	rows 4, 5, 6, 7, 8 lifted
43	rows 4, 5, 6, 7, 8 lifted
119	rows 4, 5, 6, 7, 8 lifted
5 min down time	4th course center (20" in from left the right) clip permanent deformation
140mph 0.5min in	rows 4, 5, 6, 7, 8 lifted
150mph 5.5	rows 4, 5, 6, 7, 8 lifted
160 mph 10.5	rows 4, 5, 6, 7, 8 lifted
End

Representative Photograph Deck #2: One clip exhibits permanent deformation.
