To: Corinne Schevin **Date:** June 23, 2014
From: Jason Simmons
Subject: Test Status for Bora Bora

Product samples were received from Tikimundo on April 21, 2014 for testing in accordance with **ASTM D 3161-13: Standard Test Method for Steep Slope Roofing Products (Fan Induced Method)**. Results for the testing are contained below.

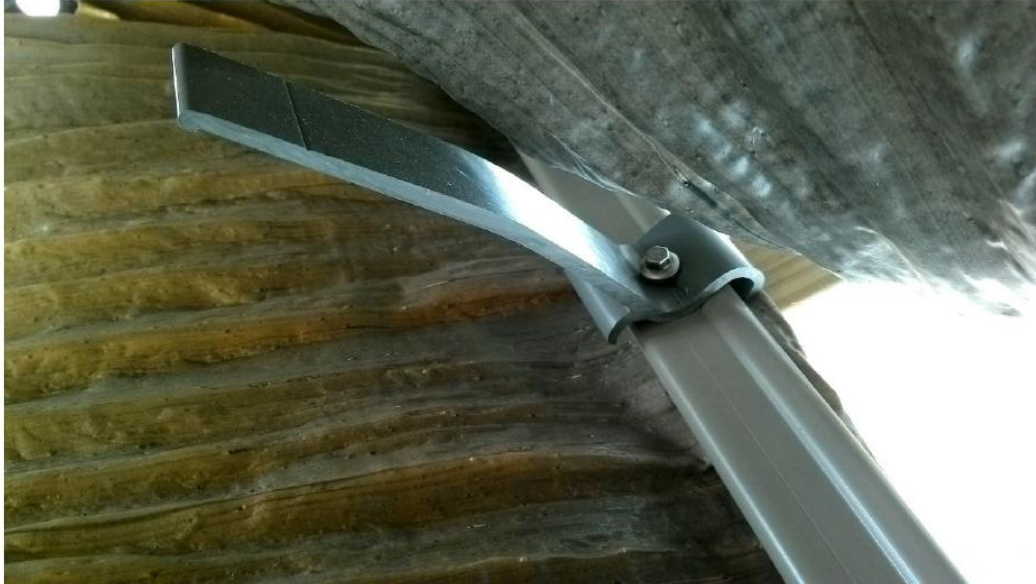
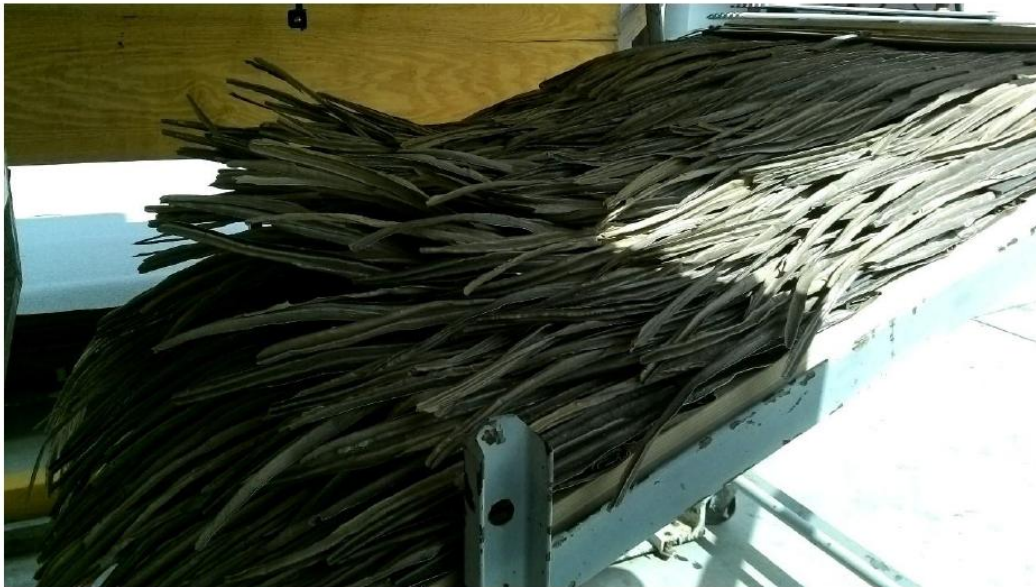
Test Observations	
Run Time (min)	Comments
Start	rows 4, 5, 6, 7, 8 lifted
0.5	rows 4, 5, 6, 7, 8 lifted
43	rows 4, 5, 6, 7, 8 lifted
119	rows 4, 5, 6, 7, 8 lifted
5 min down time	4th course center (20" in from left the right) clip permanent deformation
140mph 0.5min in	rows 4, 5, 6, 7, 8 lifted
150mph 5.5	rows 4, 5, 6, 7, 8 lifted
160 mph 10.5	rows 4, 5, 6, 7, 8 lifted
End

Representative Photograph Deck #2: One clip exhibits permanent deformation.
